68 BSA Café Project

Due to some damage to the last frame my 68 BSA needs a new one. Through my work and putting around I get to see a lot of café mods, some very cool looking bikes. But I also have noticed that one item that should get a lot of attention usually gets a new coat of paint and forgotten about. So I thought it would be a good start to these articles to walk through what I do to prep my frames for the road and track.

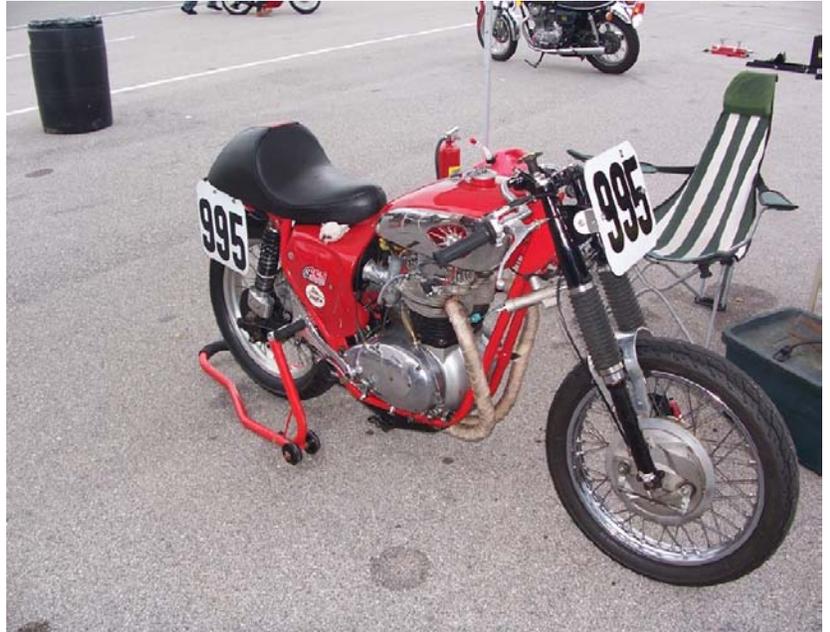
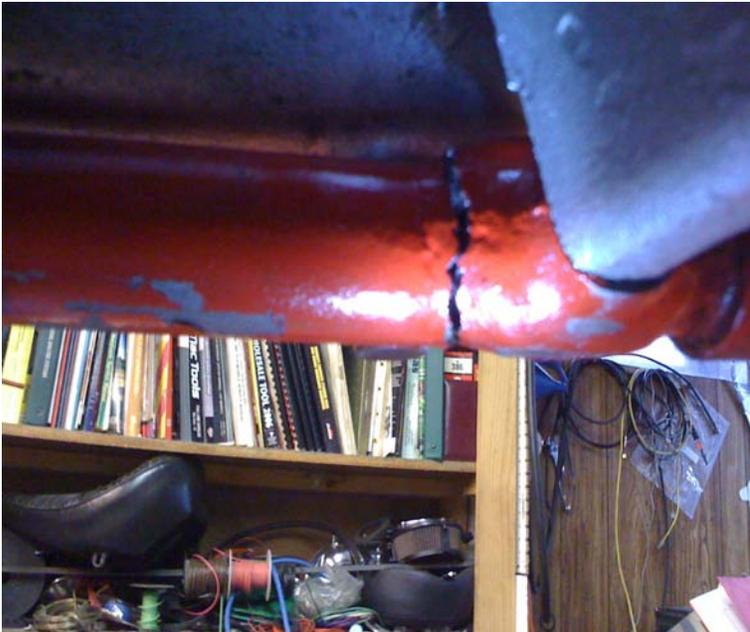
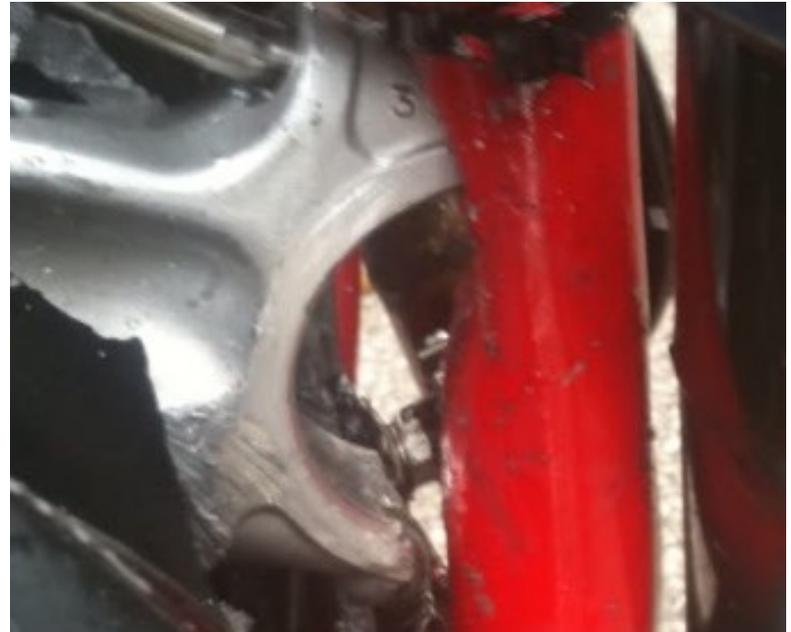
The photo on the left shows a crack or break in the frame just aft of the lower motor mount. This happened at Barber due to the frame twisting during cornering. The pic on the right is a connecting rod that decided it needed a new home at Road America. Now both areas were repaired and the bike did get back out on the track but sense the race bike has now gone to an modified OIF I felt it was a perfect time to bring the 68 back to the street.

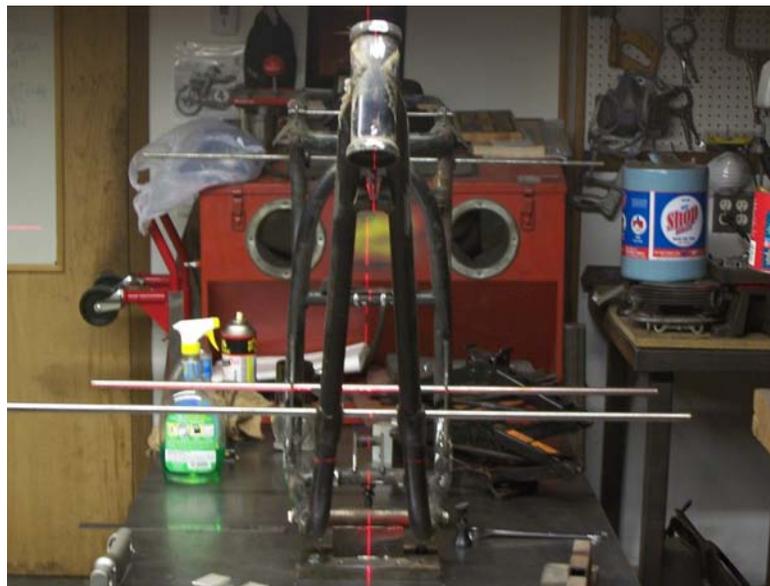
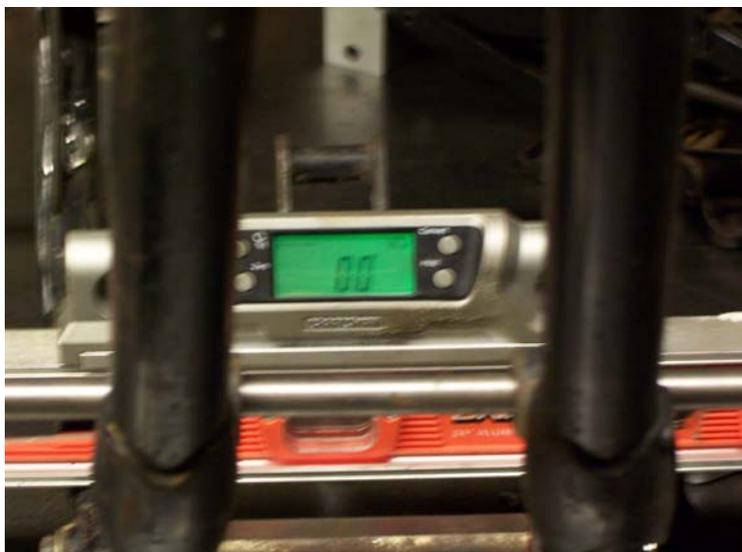
Now the first thing we're going to need is a level surface to work from. My table is a little over kill for a once in a while job it's a 1.5" thick solid steel and it is within $\pm .002$. The first think I do is a visional inspection and in this case the rear peg mount was bent but not were you would think it had damaged the rest of the bike. But then looks are always deceiving.

The table has a grid engraved into it which allows me to set up a self leveling laser that shots down the table and from floor to ceiling. I have a jig that bolts to the table and than to the lower motor mount, the jig is centered on the grid so now the frame is centered on the table. I then spend a good amount of time making sure that the frame bolts into the jig level before I start measuring.

Then I set the backbone to the same angle as listed in the engineering specs. Now we can start taking a look at the true condition of the frame.

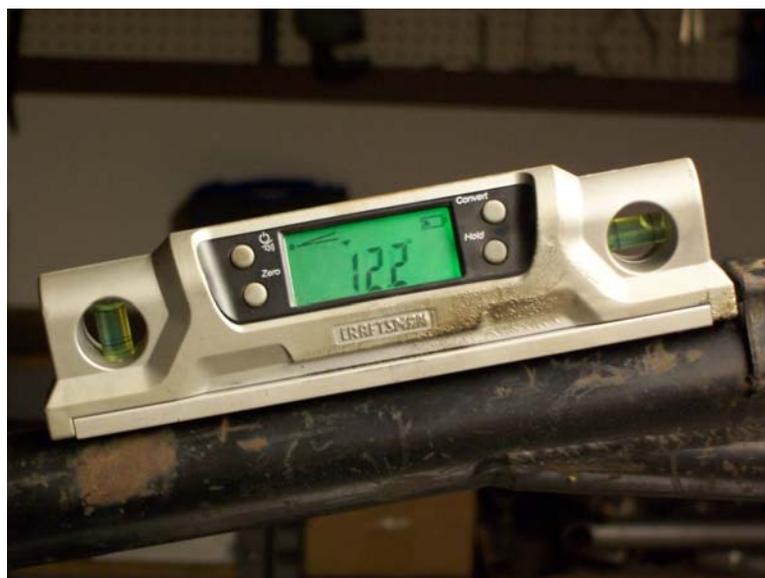
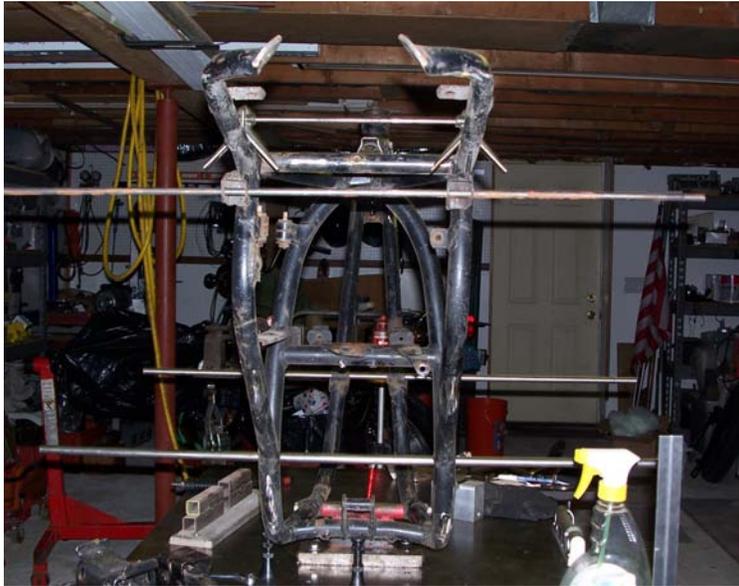
By inserting lengths of drill rod into the mounting points of the swing arm, shocks and motor a clear picture of what we're working with becomes apparent.

Now between the laser and the drill rod I can see that the swing arm mounts are off the shock mounts are bent badly and the whole frame is actually twisted a little.

It may surprise some that there is this much wrong with a frame that "looked" in good condition but don't be I have yet to put a British frame on the table that was perfect.

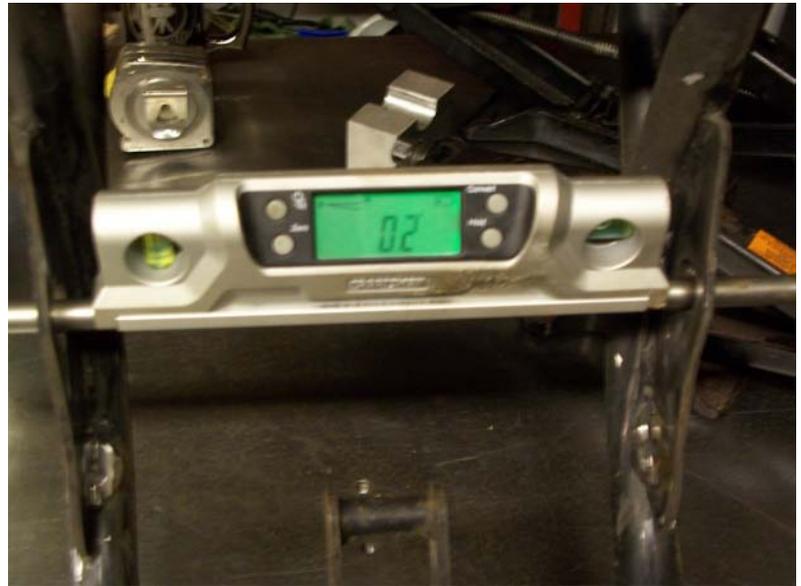
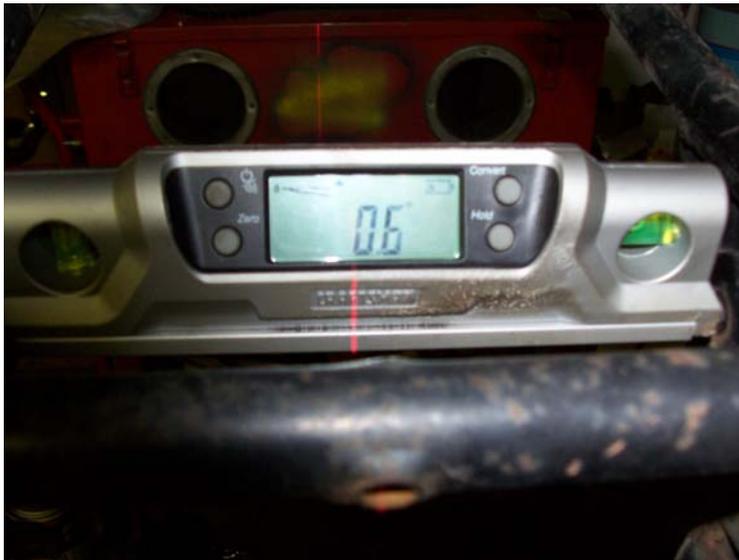
This frame is 43 years old and you know its been down a few times over the years plus back then they were hand built using jigs and if the guy had a few to many the night before or just

the normal wear of the jig allowed the frames to be off a little here and there. Because of the twist the neck is tilted to the right and the swing arm to the left. I'm not real worried about the shock mounts that a pretty easy fix. The swing arm offers a interesting opportunity though, the bikes handling would benefit from the mount being moved up about a half an inch. Well that's as far as I can go this weekend house needs some work to, I'll add more as the project continues.
